Analysis of object cracks dilation caused by thermal changes

After eighteen years of use, scratches and cracks were noted on the walls and floor of this structure. They indicate the presence of deformation in its structure. The scratches were examined on an object located on the UTP campus in Bydgoszcz. It was built in 2001 and has since served as an above-ground passage connecting University buildings. The outside and shape of the structure are shown in Figure 1.

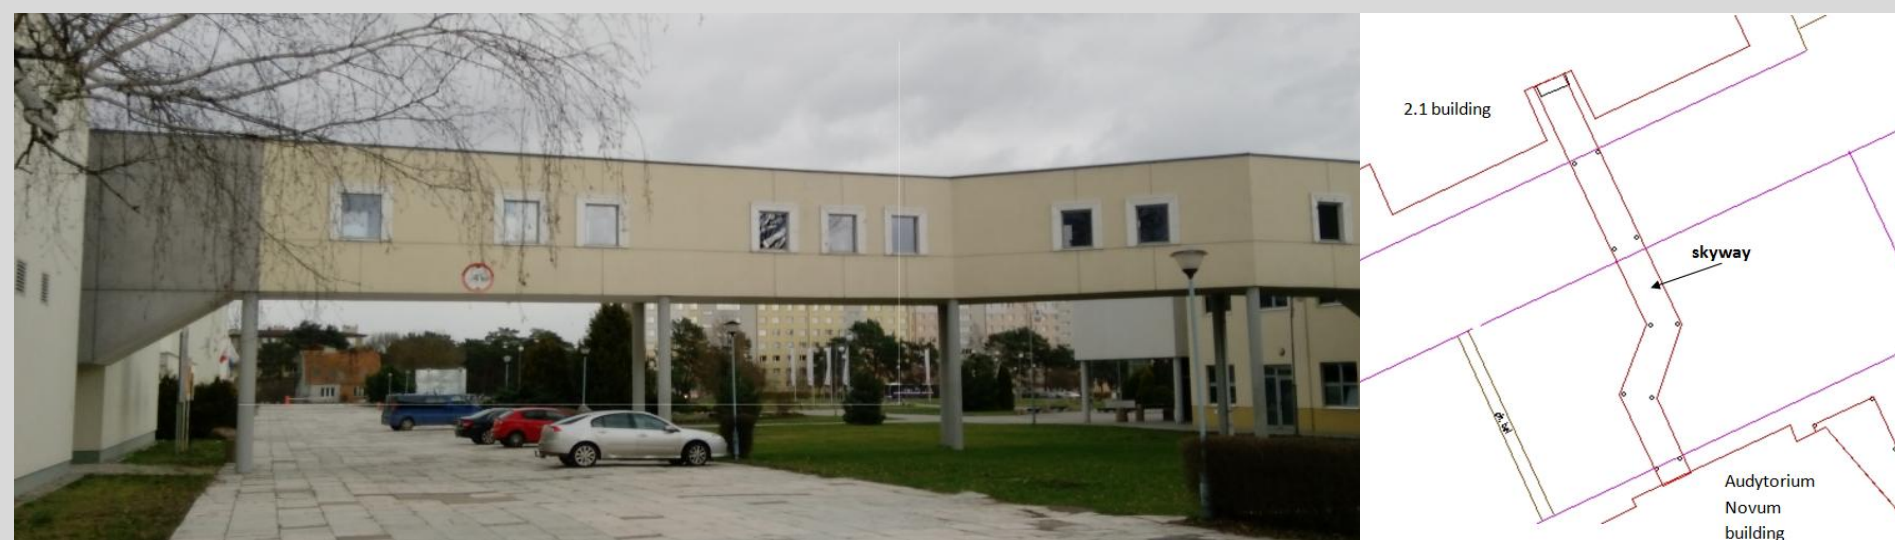
Fig. 1. The outside and shape of investigated object

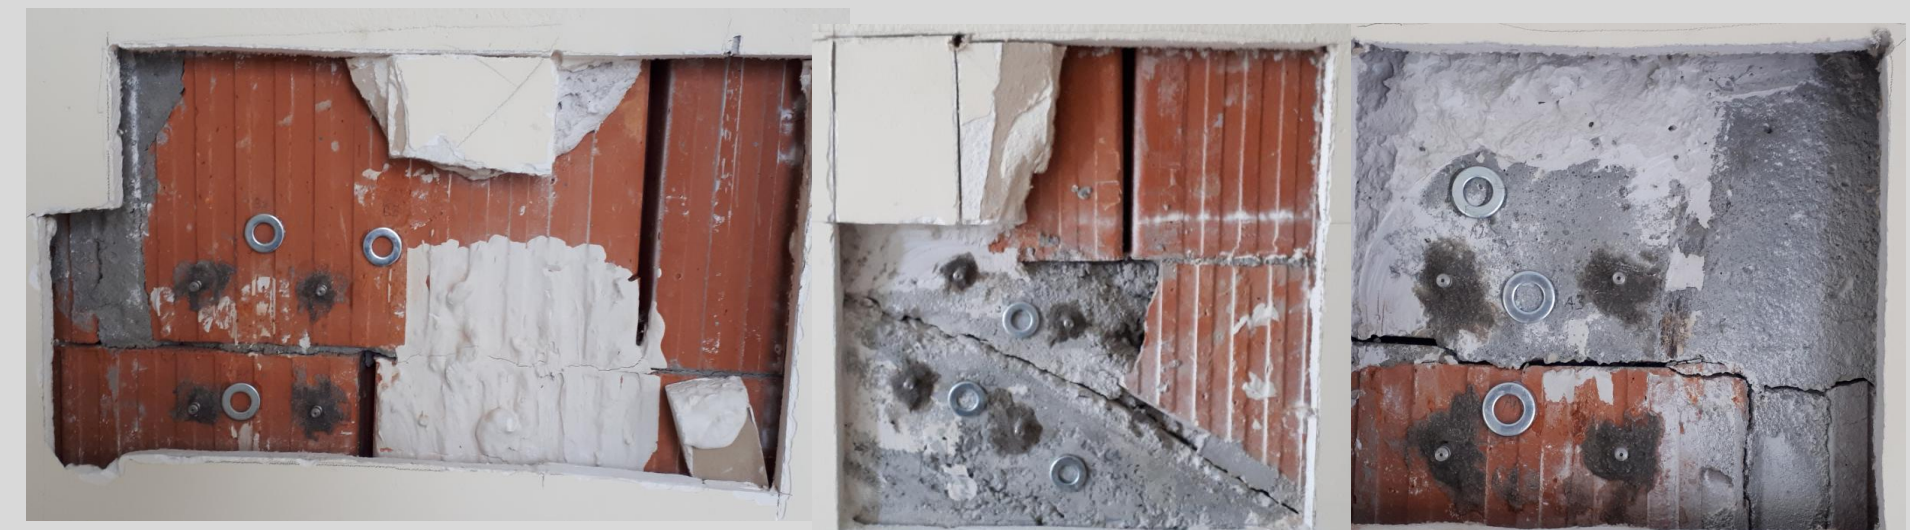
As part of the investigations in the places of structure cracks, the SHM X crackmeter was used to measure the crack width. At the same time, geodetic measurements of the displacement and control network were made. Measurements using the TDRA6000 laser station with instrumentation allowed us to obtain submillimeter accuracy of determining point displacements. The network-controlled points were also placed in places where the crack opening was directly observed. This gave the opportunity to observe the displacements of the scratches in a uniform spatial coordinate system. The results of opening the scratches obtained from both methods were also compared. Figure 3 shows the location of the measuring network of two methods (pins and washers) next to the resulting cracks.

Fig. 3. The location of the measuring network of two methods next to the resulting cracks

Construction monitoring covered three seasons. During this time, 35 series of measurements of crack openings were made in relation to pins and four series of geodetic measurements. Detailed analysis of the results will be presented in the article.
